**REPORT NUMBER: 214-CAL-07-05**

**SAFETY COMPLIANCE TESTING FOR FMVSS 214  
SIDE IMPACT PROTECTION  
INDICANT**

**GM DAEWOO AUTO & TECHNOLOGY COMPANY  
2007 CHEVROLET AVEO  
4-DOOR NOTCHBACK**

**FINAL REPORT**

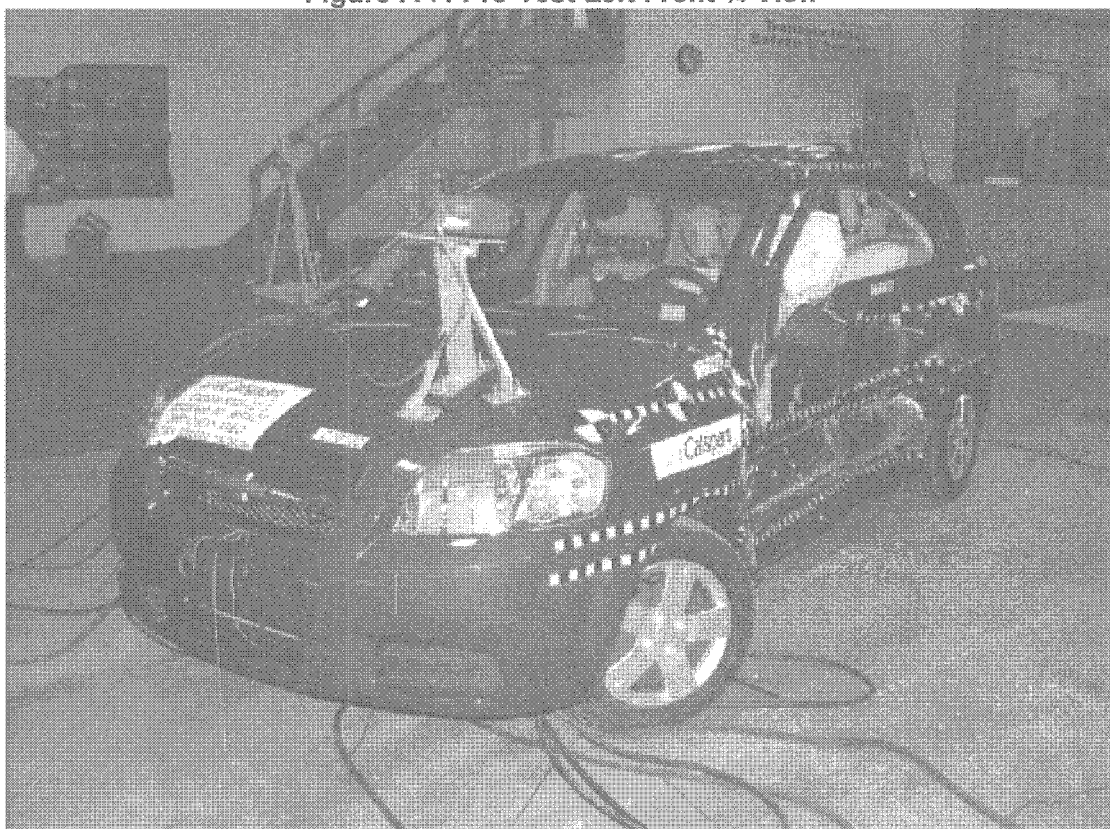
**Figure A-8: Post-Test Left Front  $\frac{3}{4}$  View**

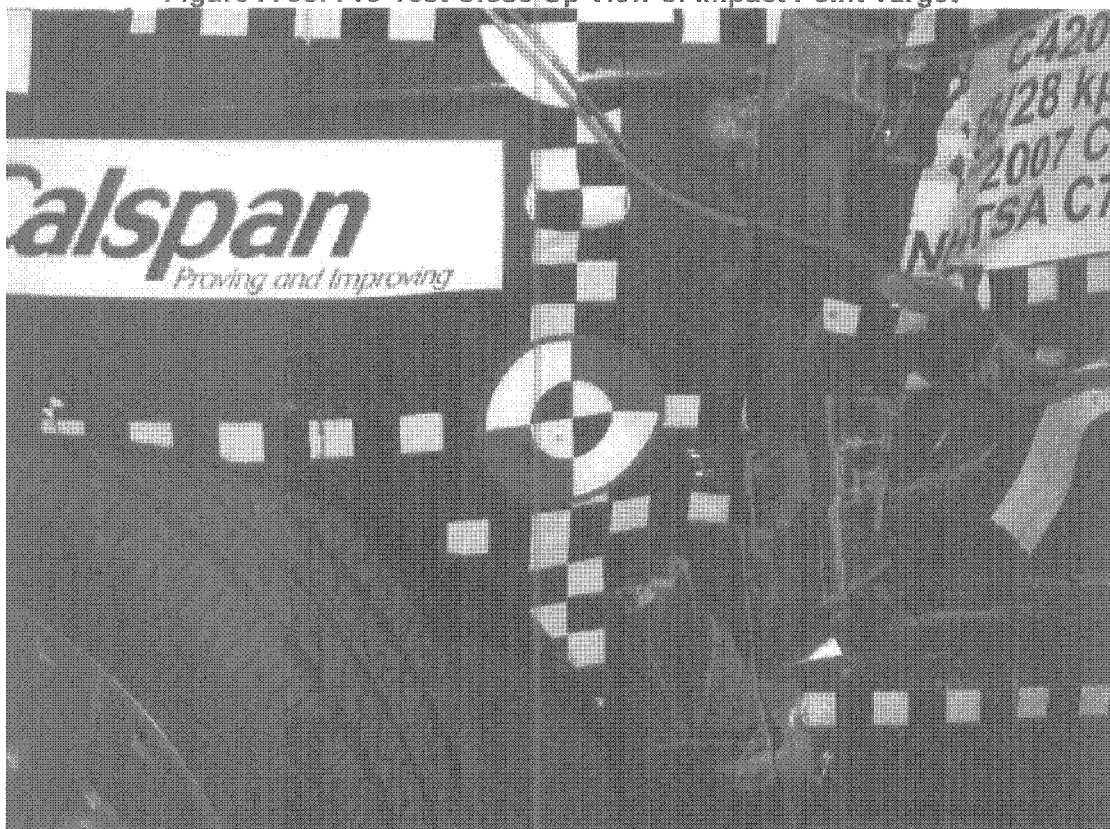
Figure A-34: Post-Test Close-Up View of Impact Point Target

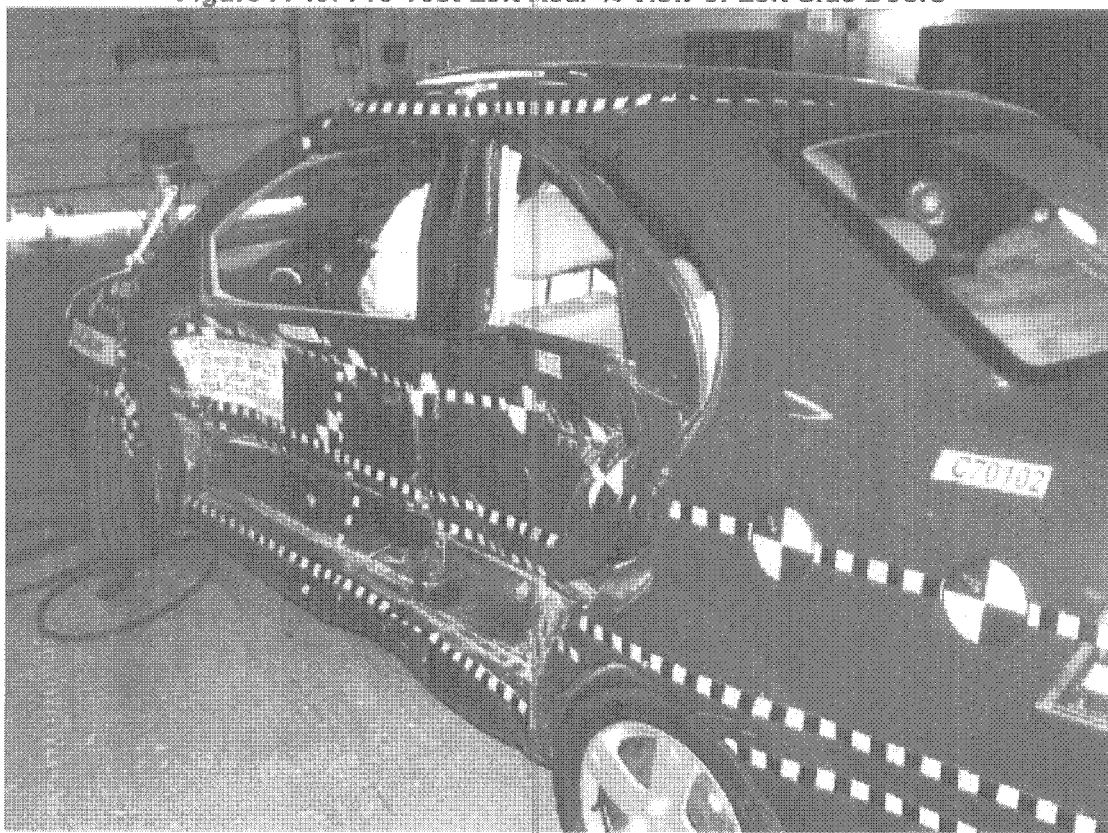
**Figure A-50: Post-Test Left Rear  $\frac{3}{4}$  View of Left Side Doors**
